Wind Turbine Monitoring of an Operational Wind Farm in Ireland

Remote and autonomous inspection and maintenance of onshore and offshore wind turbines (REMOTE-WIND)

A comprehensive decision support tool for end-of-life wind turbines of Ireland; Lifetime Extension, Decommissioning, Repowering, Repurposing [WindLEDeRR]

- Bord Na Móna (BNM) facilitated and collaborated with the implementation of aspects of the WindLEDeRR and REMOTE-WIND projects
- Bellacorick Wind Farm, County Mayo, Ireland

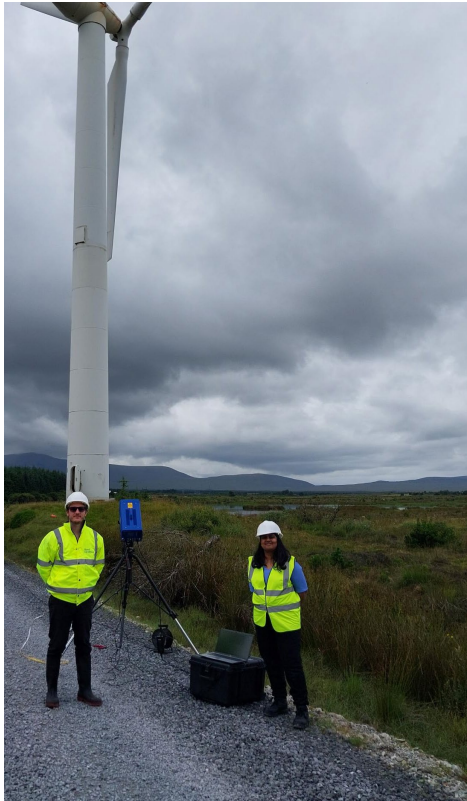
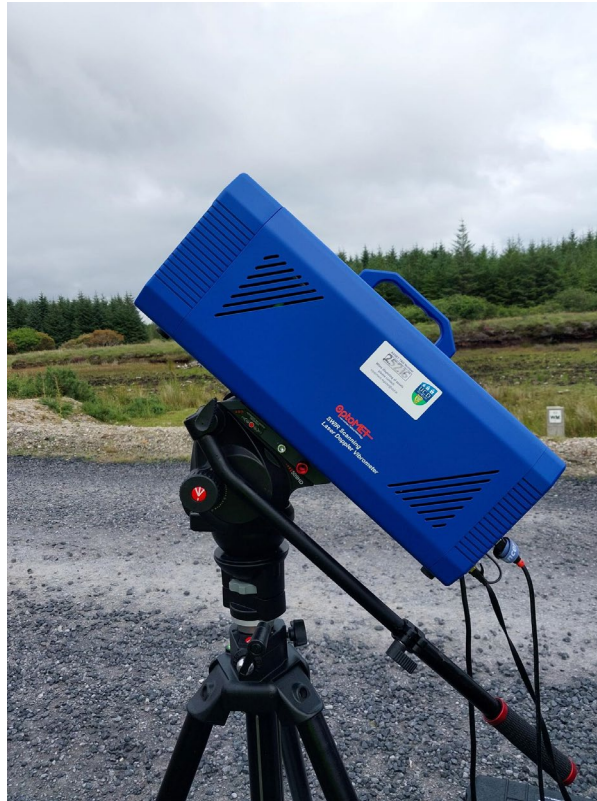
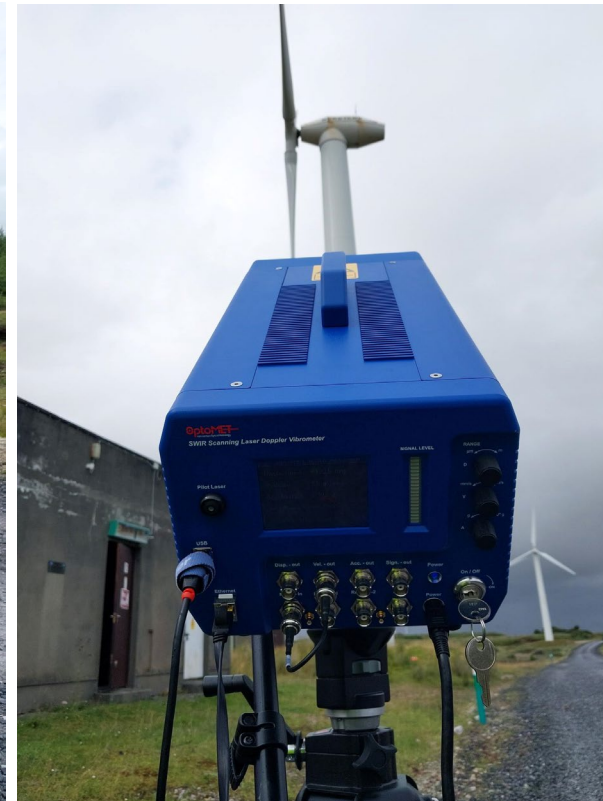
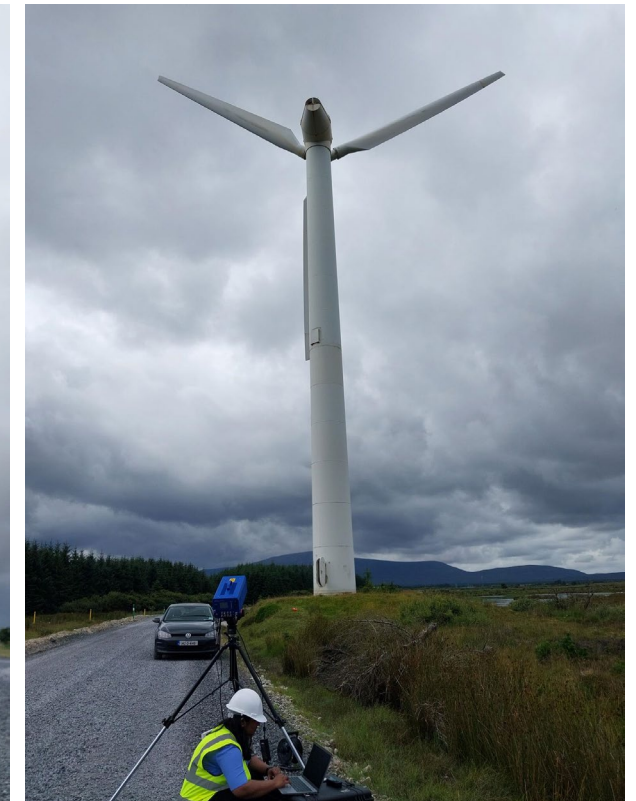
REMOTE-WIND: Laser Doppler Vibrometry (SWIR-LDV)

- Full-Scale Demonstration of Laser Doppler Vibrometry (SWIR-LDV)
- Optical method for non-contact analysis of vibrational velocity and displacement of vibrating structures
- measures doppler frequency shift by focusing laser light on object of interest eg wind turbine

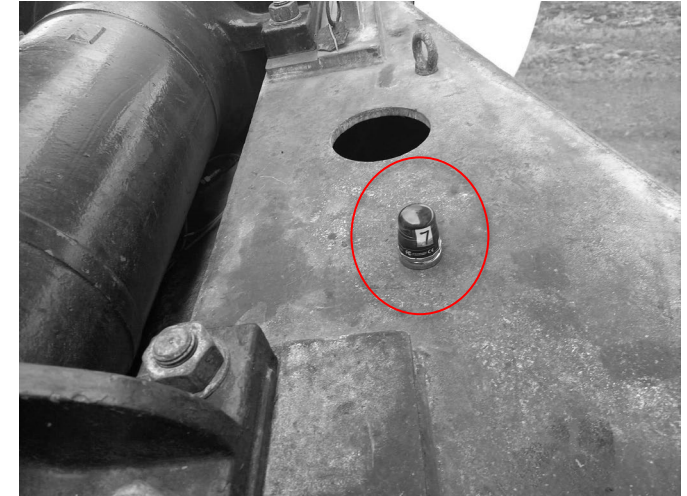
REMOTE-WIND: Laser Doppler Vibrometry (SWIR-LDV)

- Comparison of LDV with data from wireless accelerometers installed within tower:
 - Close to tower bottom
 - Mid Tower
 - Close to tower top
 - Nacelle (to monitor maximum acceleration levels, no more than ~0.15-0.20g)
- Wireless accelerometers installed 90 degrees apart at each height to measure values along 2 axes
- Values of structure natural frequency measured by LDV compared with data from wireless accelerometers
- Natural frequency is proportional to square root of stiffness, and stiffness is connected to potential degradation of material (steel) / interconnection with foundation
- Testing of multiple WTGs would permit the determination of natural frequencies, and outliers may be indicative of structural issue for further investigation

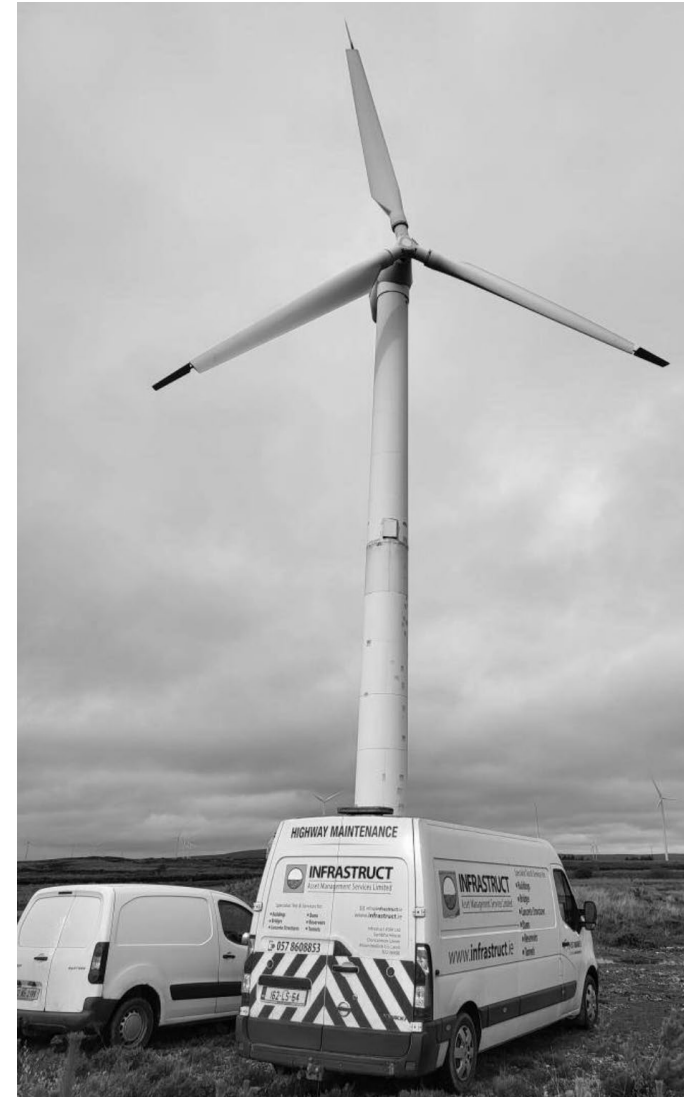
- Why assess condition of foundation?
 - Determine quality of concrete on site after long operational period (since 1992)
 - Determine condition of steel reinforcement ('rebar') in the concrete foundation
 - Undertake inspections to aid the determination of Remaining Useful Life
 - Health and Safety
 - Foundation is a fundamental part of the overall wind turbine structure (foundation – tower interaction), however concealed from view
 - Confirm As-Built Foundation Design and Dimensions matches that on Design Drawings (sometimes not available for very old assets!)
- What can impact foundation condition?
 - Potential cracking of concrete, due to site loading conditions, or foundation degradation
 - Environmental conditions: Peatland environment can have slightly acidic properties
 - Hidden defects / voids in concrete that could potentially have been in-situ from time of construction

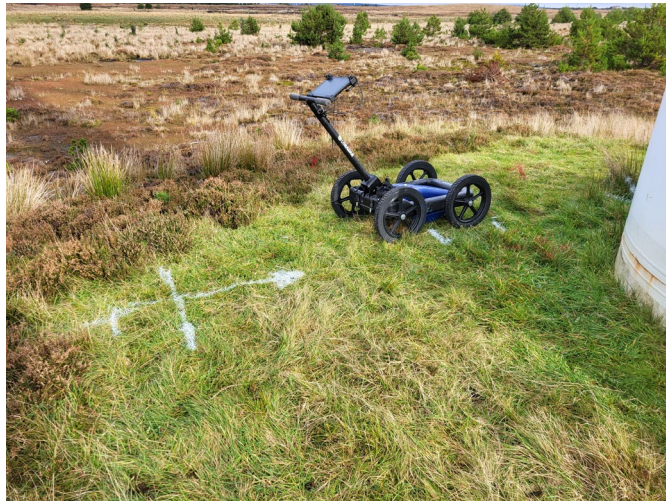
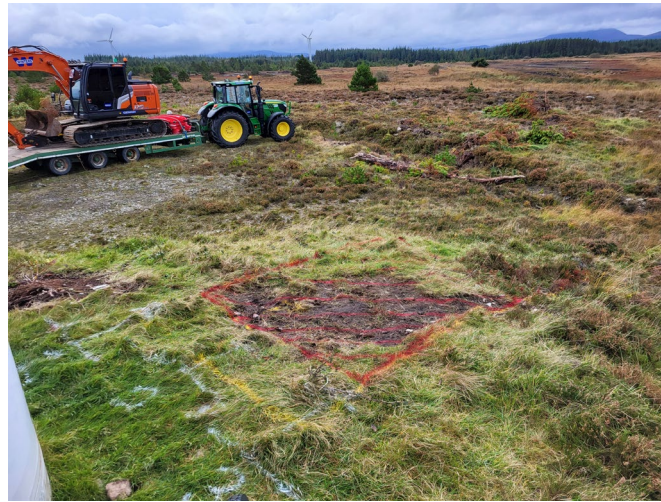
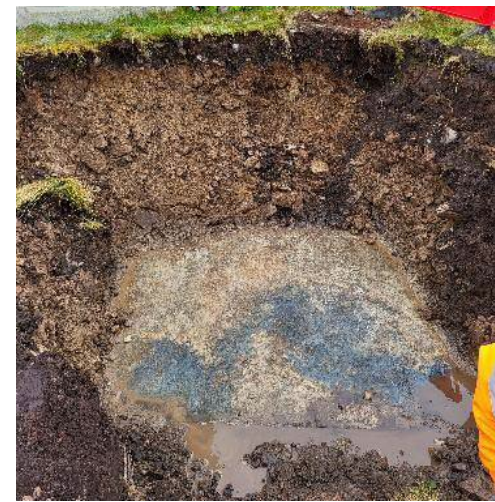
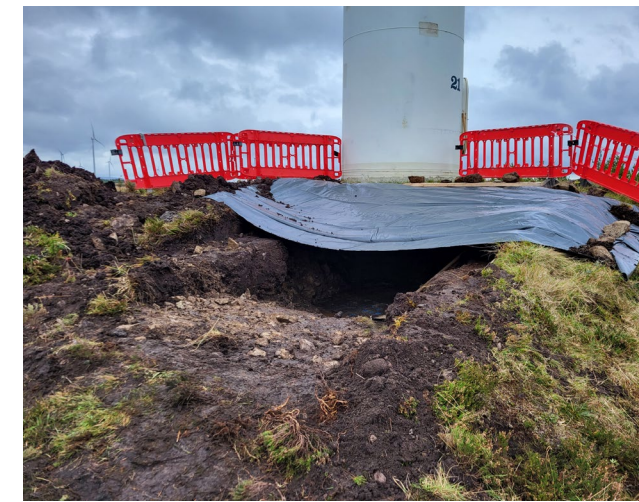
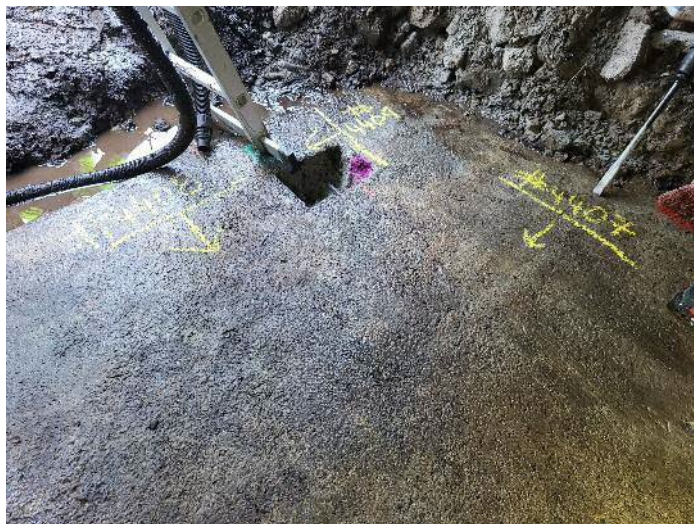
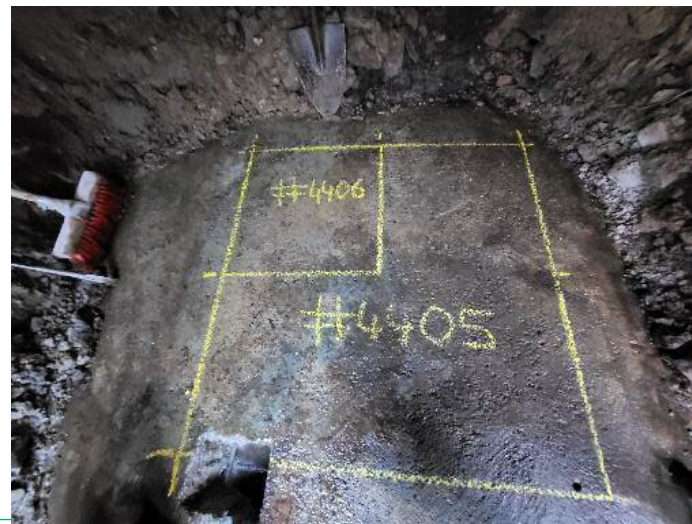
WindLEDeRR + REMOTE-WIND: Foundation Inspection + Monitoring

- Site Preparation: Wind Turbine Shut Down and Isolated

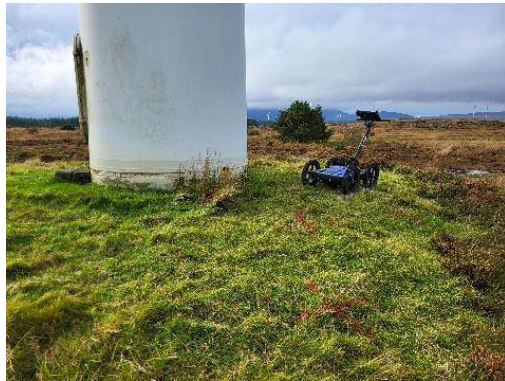
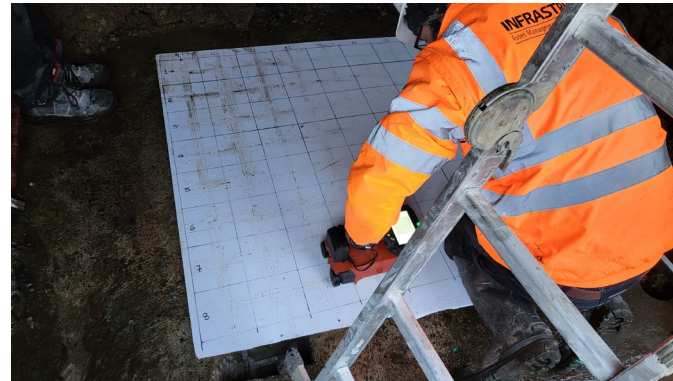
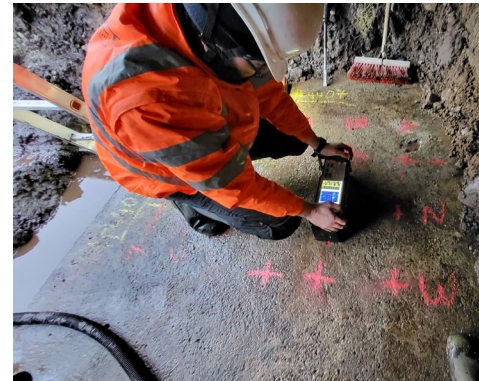
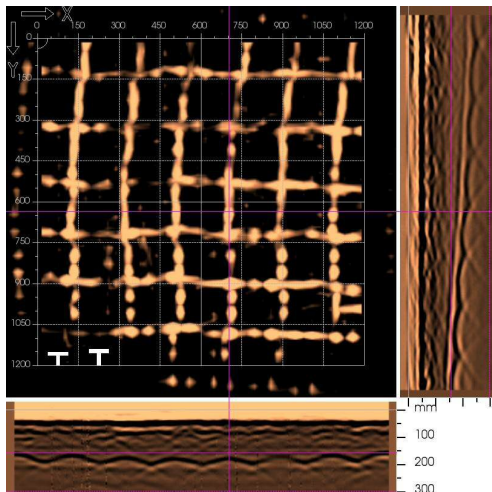
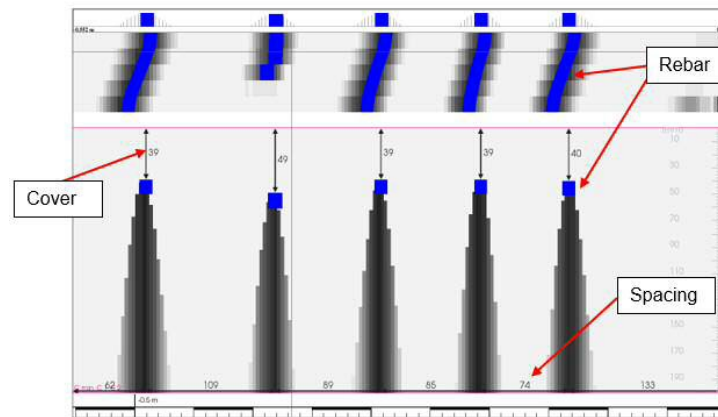
WindLEDeRR + REMOTE-WIND: Foundation Inspection + Monitoring

- NDT: GPR systems used to find
 - buried services
 - Reinforcement position
- NDT: Concrete detector:
 - rebar localisation
 - depth measurement
 - size estimation
- NDT: Ultrasonic Tomography
 - depth measurement
 - Concrete integrity (voids)
- NDT: Reinforcement Corrosion Assessment:
 - Half Cell Potential
 - Resistivity

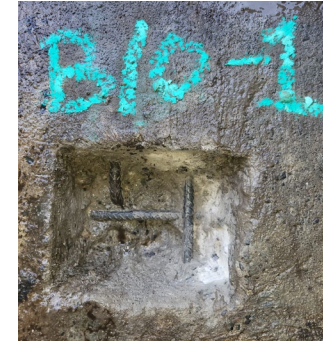
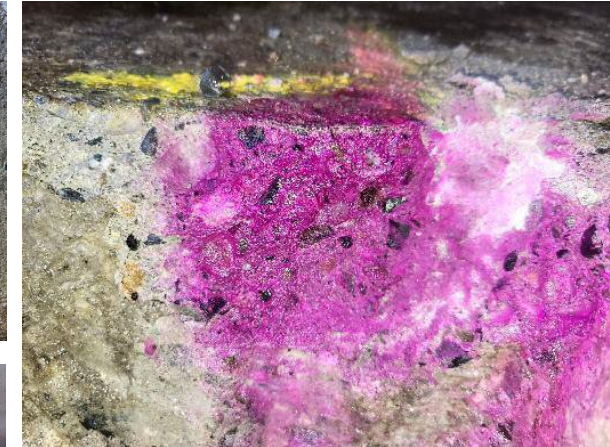
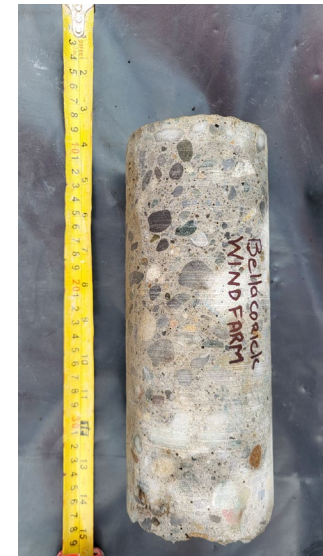
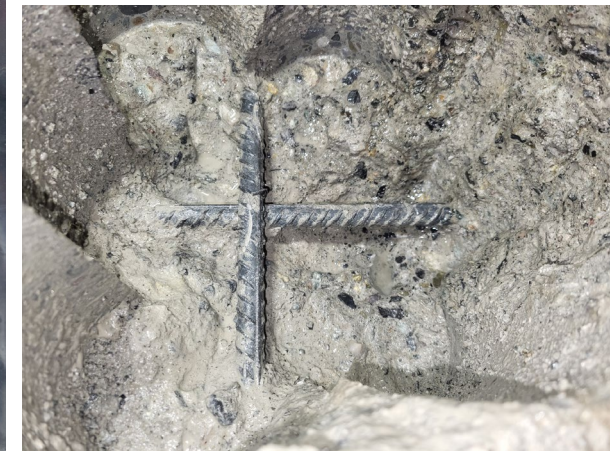
WindLEDeRR + REMOTE-WIND: Foundation Inspection + Monitoring

- No Carbonation
 - At both breakout depth and surface, indicated by pink colour
- Low Chlorination
 - Drill into concrete, 3 small holes, collect dust from holes, and send for Lab analysis
 - Low chloride 0.02% measured, very good result (ie natural chlorides), below 0.4% chloride by mass of cement represents a low corrosion risk
- Visual Inspection indicated rebar in excellent condition
- High level of concrete cover exceeding current minimum requirements
- 100mm diameter Concrete cores and ‘breakout’ samples sent for testing to test
 - Compressive Strength
 - Cement Content

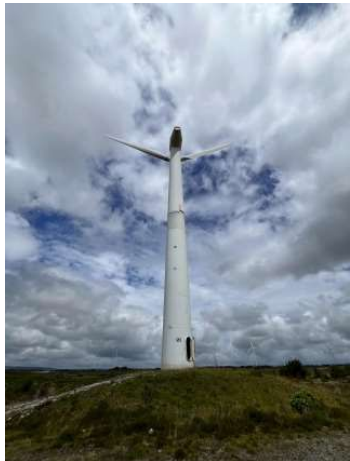
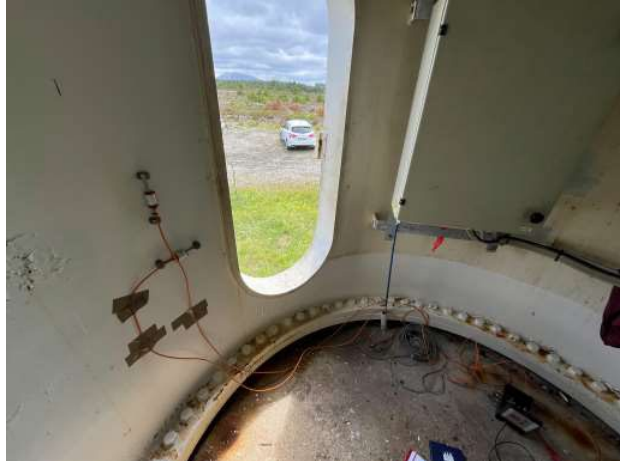
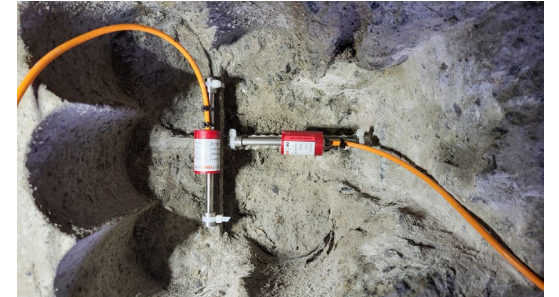
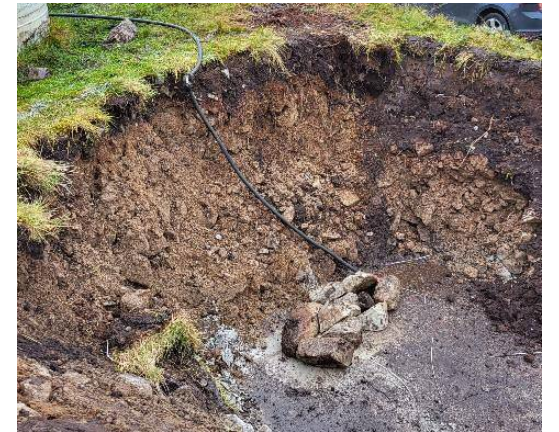
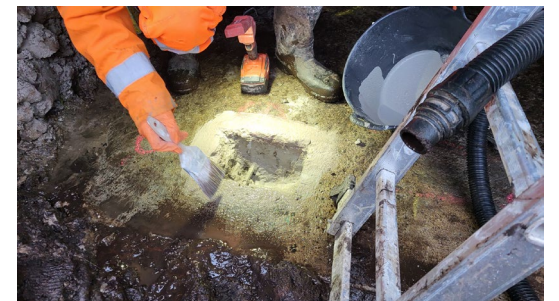
WindLEDeRR + REMOTE-WIND: Foundation Inspection + Monitoring

- REMOTE-WIND initiative to install vibrating wire strain gauges
- strain gauges measure foundation strain variation at foundation rebar over time
- Could not install strain gauges on rebar at edge of tower, due to density of rebar and also potential requirement for welding
- Strain Gauges surveyed, one N-S and one E-W
- After installation of strain gauges, breakout reinstatement using correct structural grouts with appropriate properties (eg N/mm² strength) to grout manufacturer instructions, and also ensures strain gauges do not move post installation
- Data logger installed at base of tower with 2 new gauges
